# Appendix A

## Photo Log

Tar Creek Source Material OU4 Remedial Action

Tar Creek Superfund Site, Ottawa County, Oklahoma

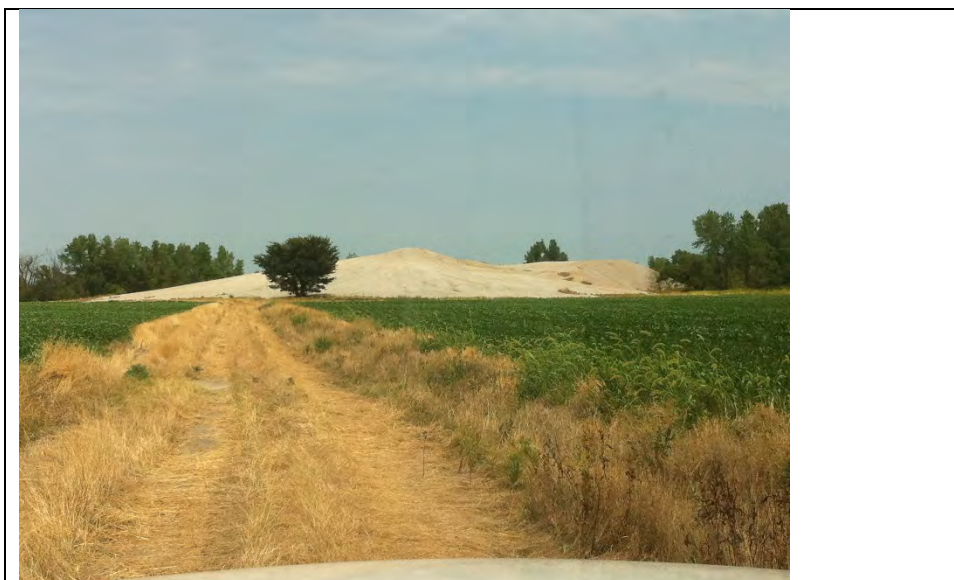
*Photograph 1*  
*TCOU4 DISTAL 4, CP 91 from Access Road, Facing North, 2011-08-04*

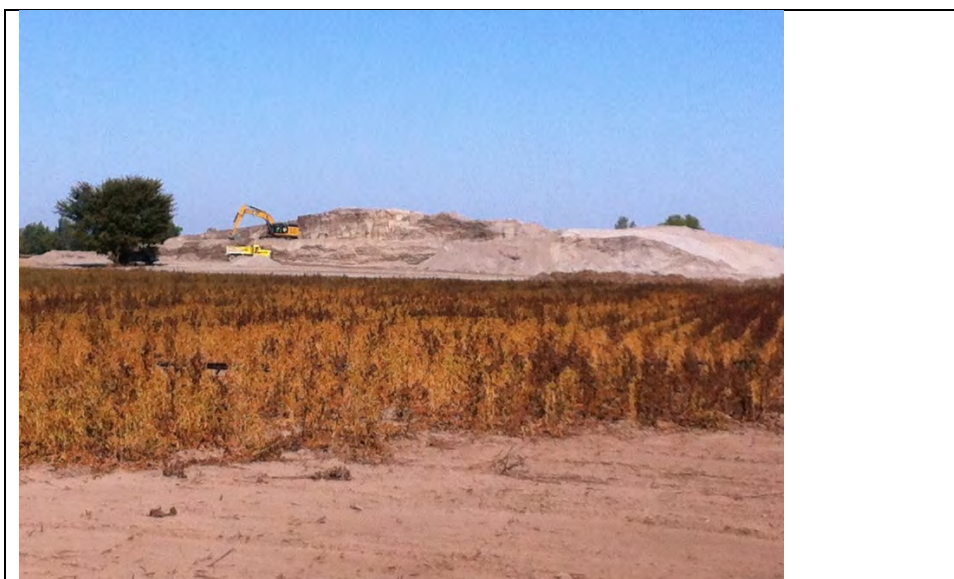
*Photograph 2*  
*TCOU4 DISTAL 4, 349 Caterpillar Track Hoe Loading Chat from CP091, Facing North, 2011-08*

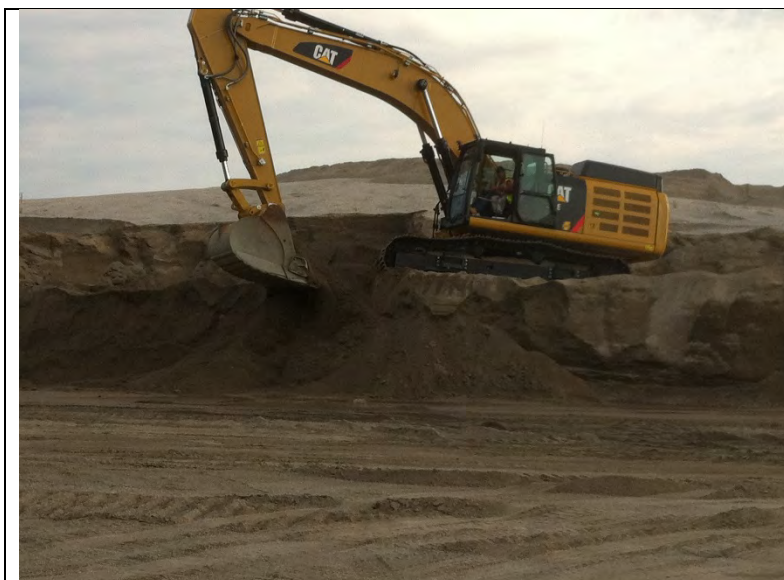
*Photograph 3  
TCOU4 DISTAL 4, 349 Caterpillar Track Hoe Loading Chat from CP091, Facing North,  
2011-08-30*

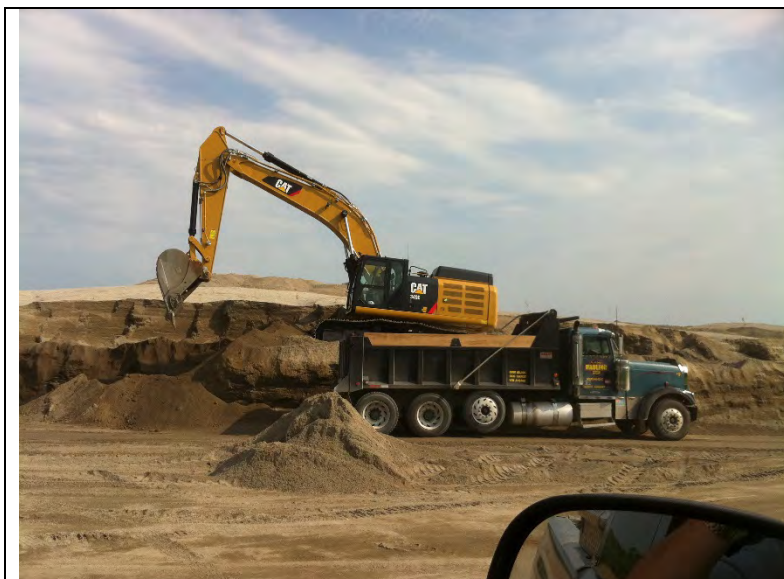
*Photograph 4  
TCOU4 DISTAL 4, 349 Caterpillar Track Hoe Loading from CP091, Facing North,  
2011-08-30*

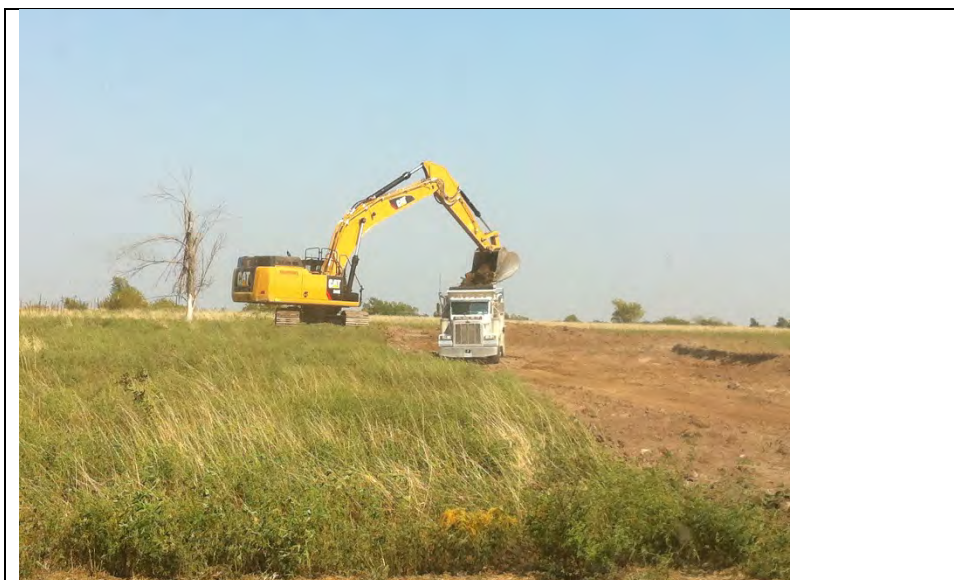
*Photograph 5*  
*TCOU4 DISTAL 4, Loading Source Material from CB231, Facing East, 2011-08-31*

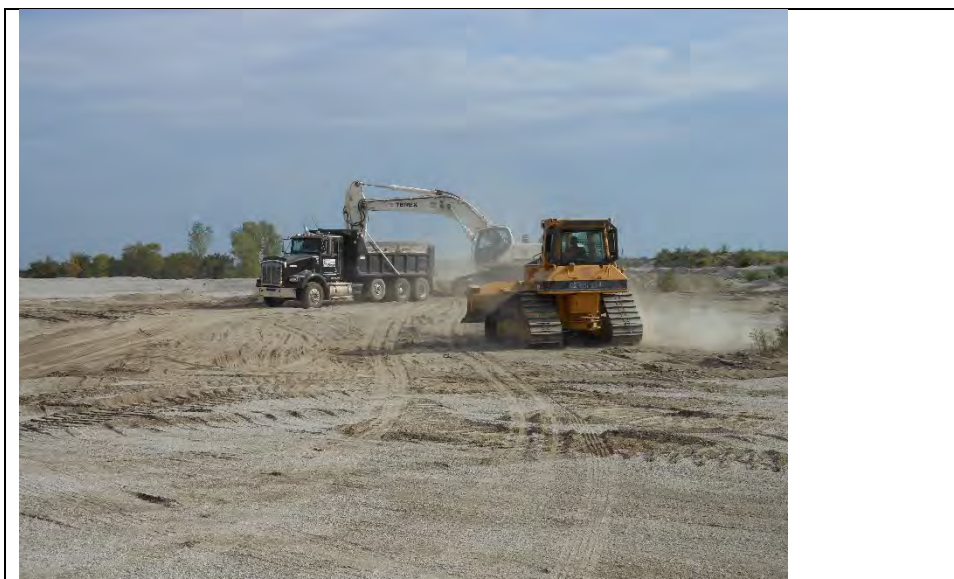
*Photograph 6*  
*TCOU4 DISTAL 4, Loading Chat Out at CP091 Grid 30, Facing North, 2012-08-08*

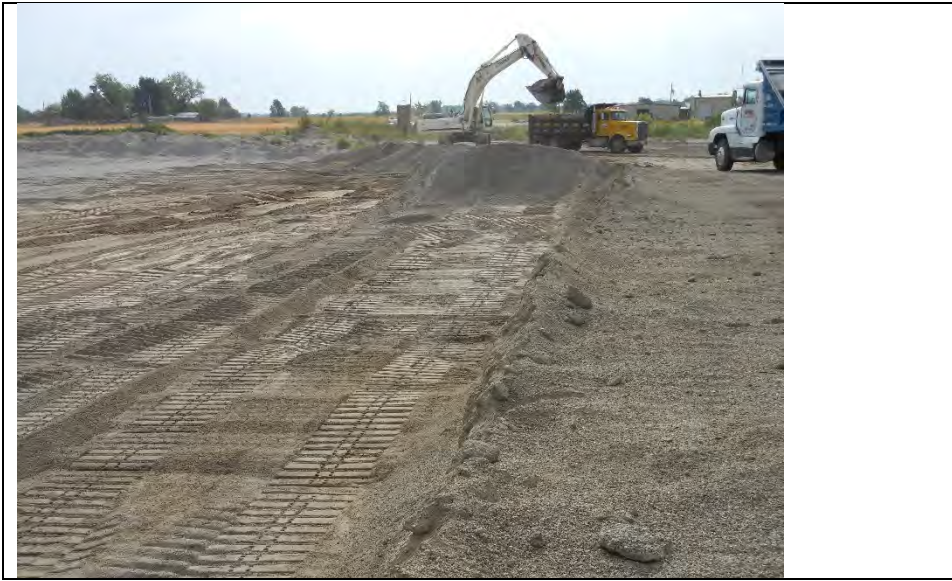
*Photograph 7  
TCOU4 DISTAL 4, Loading Chat Out at CP091 Grid 31 and Grading Bottom of Cap,  
Facing East, 2012-08-09*

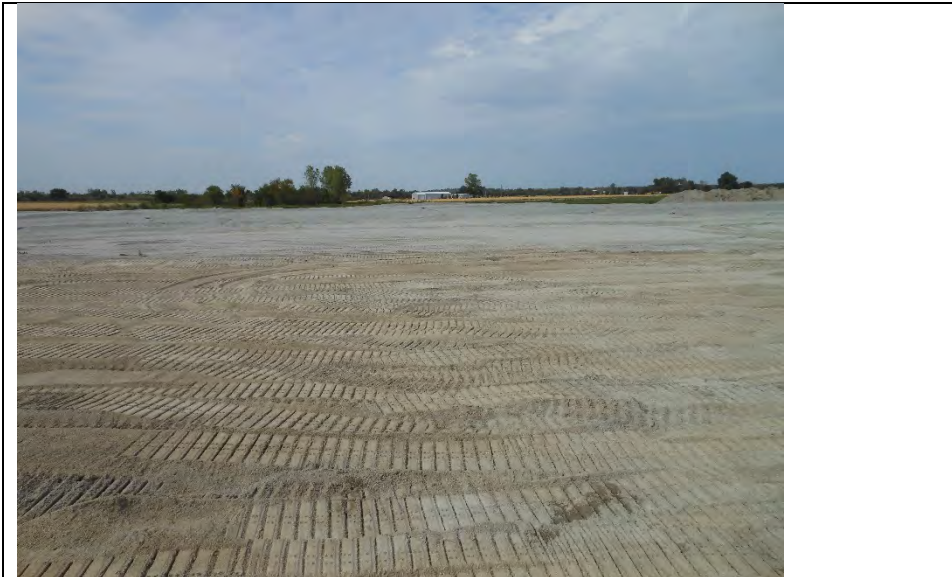
*Photograph 8  
TCOU4 DISTAL 4, Grading Base of Cap at CP091, Facing North, 2012-08-11*

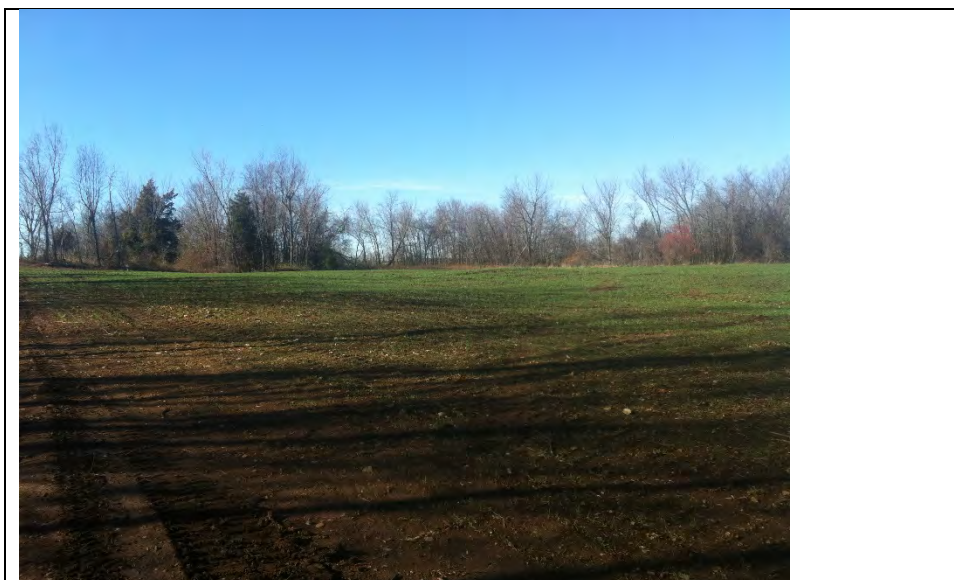
*Photograph 9*  
*TCOU4 DISTAL 4, CP093-S2 after Work Completed, Facing West, 2012-11-30*

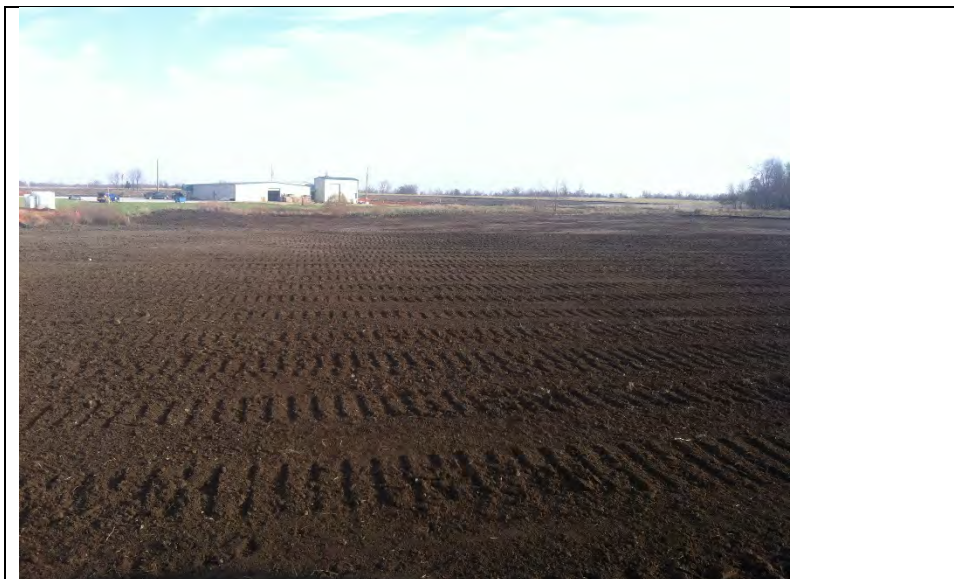
*Photograph 10*  
*TCOU4 DISTAL 4, CP091 Grid 36, TZ Soil Final Grade, Facing East, 2012-11-15*

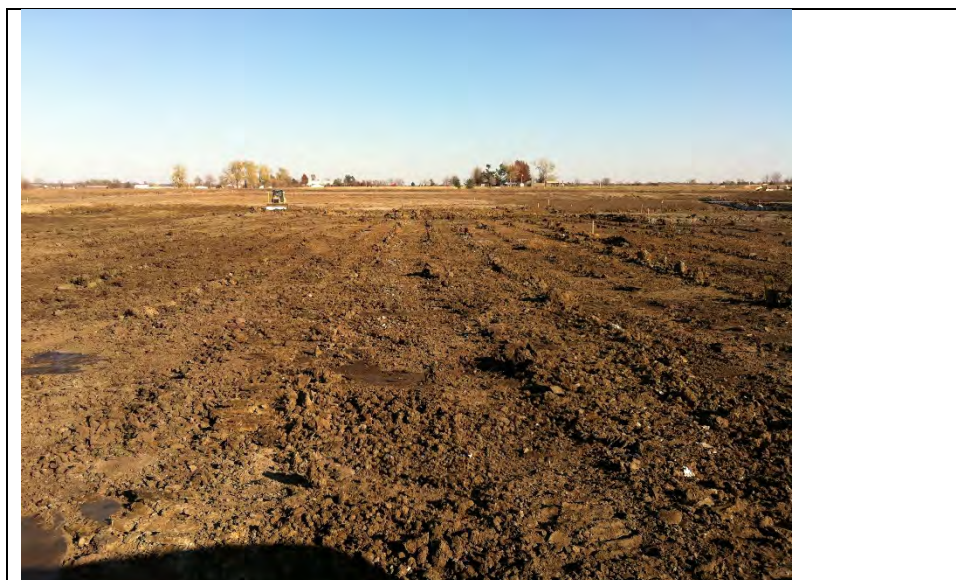
*Photograph 11*  
*TCOU4 DISTAL 4, CP091 Grid 21, Grading TZ Soil Excavated Grid, Facing East,*  
*2012-11-17*

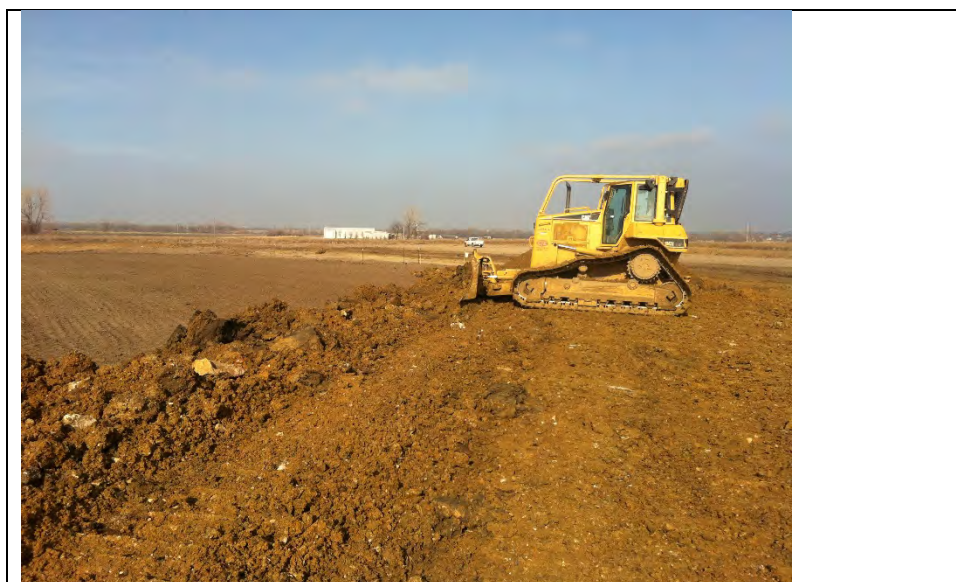
*Photograph 12*  
*TCOU4 DISTAL 4, CP091 Placement of 18-in Clean Soil on Cap, Facing North,*  
*2012-12-17*

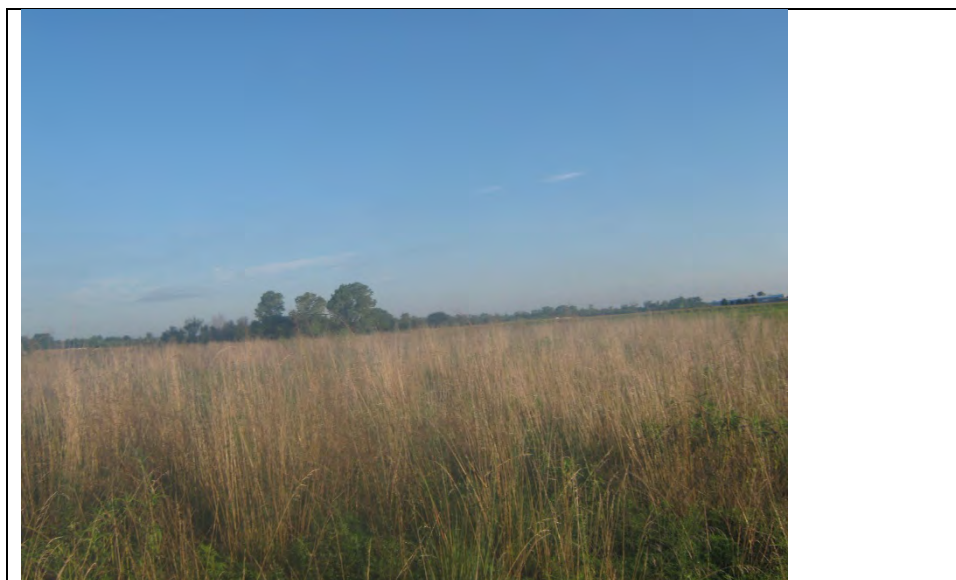
*Photograph 13*  
*TCOU4 DISTAL 4, CP091 Prior to Clearing During Site Restoration, Facing East,*  
*2015-08-10*

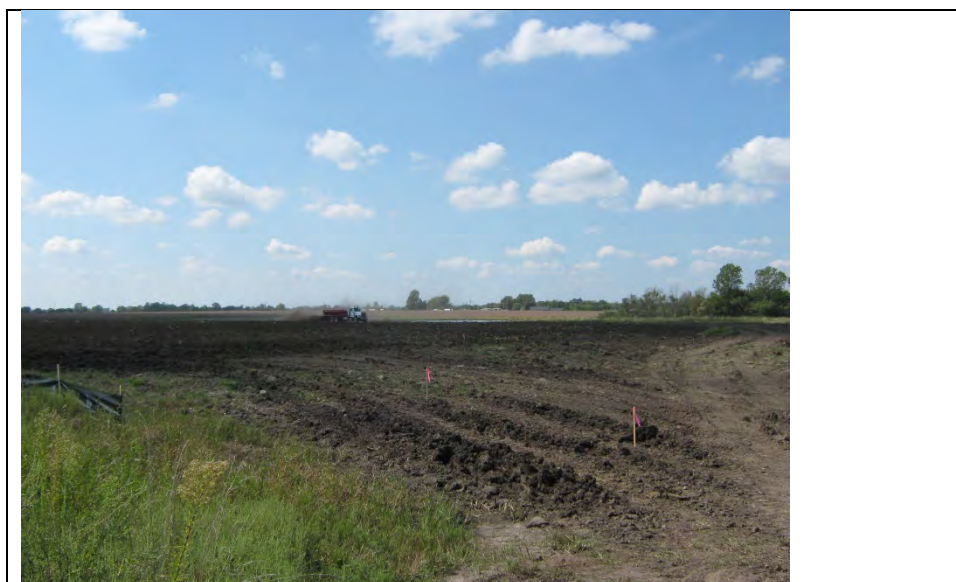
*Photograph 14*  
*TCOU4 DISTAL 4, CP091 Application of Chicken Litter, Facing Southwest, 2015-09-03*

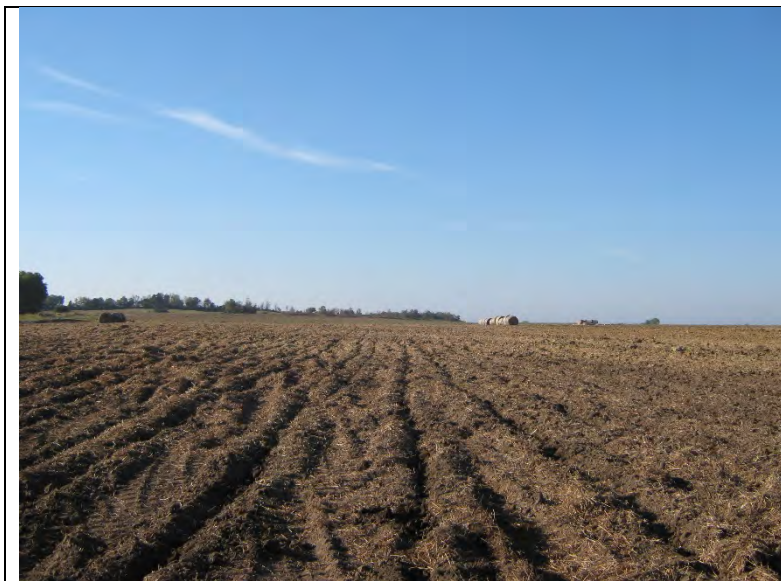
*Photograph 15*  
*TCOU4 DISTAL 4, CP091 View of Cap after Application of Amendments, Facing East,*  
*2015-09-26*

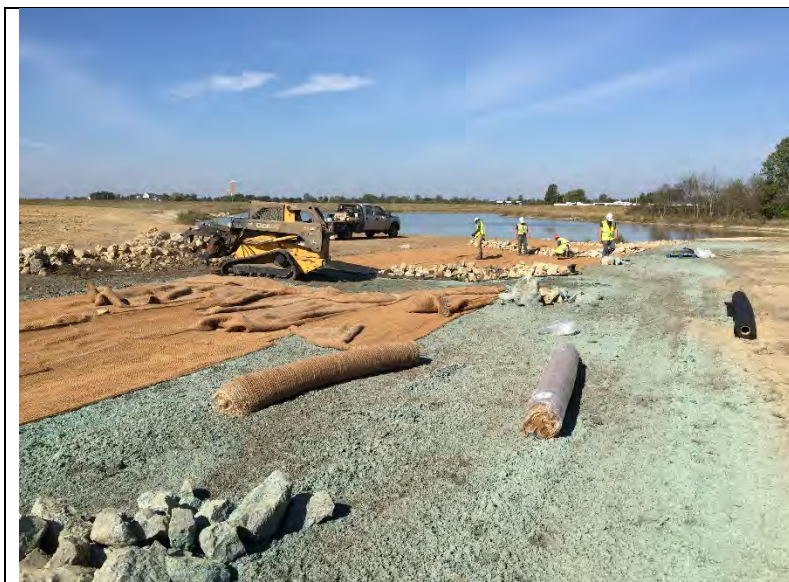
*Photograph 16*  
*TCOU4 DISTAL 4, CP091 Construction of Drainage Swale Rock Check Dams/Coconut*  
*Fabric, 2015-10-02*

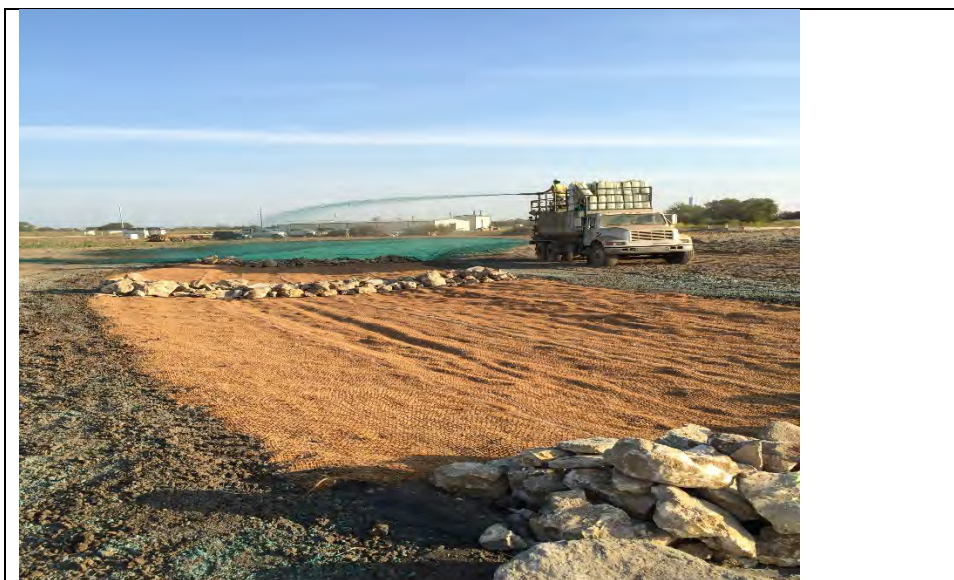
*Photograph 17*  
*TCOU4 DISTAL 4, CP091 Hydroseeding Drainage Swale, 2015-10-02*

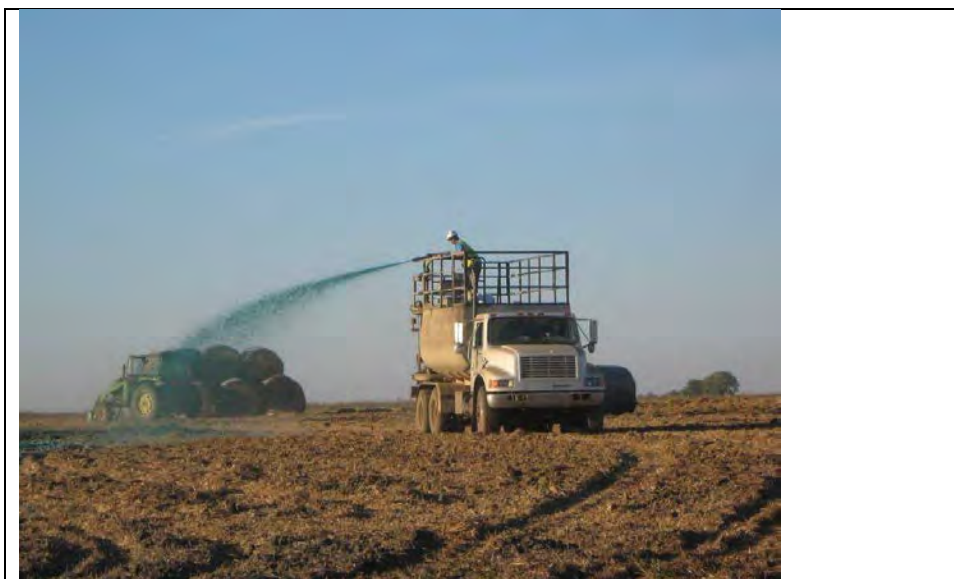
*Photograph 18*  
*TCOU4 DISTAL 4, CP091 Hydroseeding Cap, 2015-10-02*

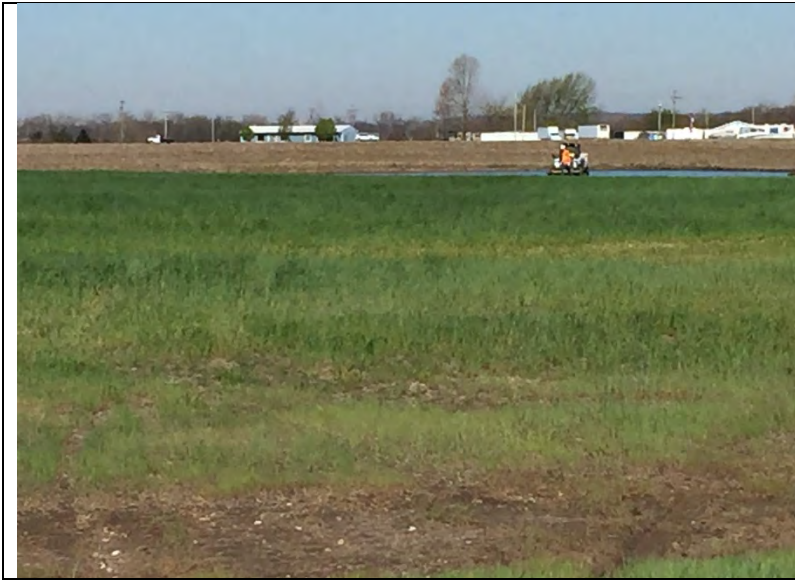
*Photograph 19*  
*TCOU4 DISTAL 4, CP091 View of Cap after Growth of Annual Cereal Rye from Hydrosseding, Facing Northwest, 2016-03-28*

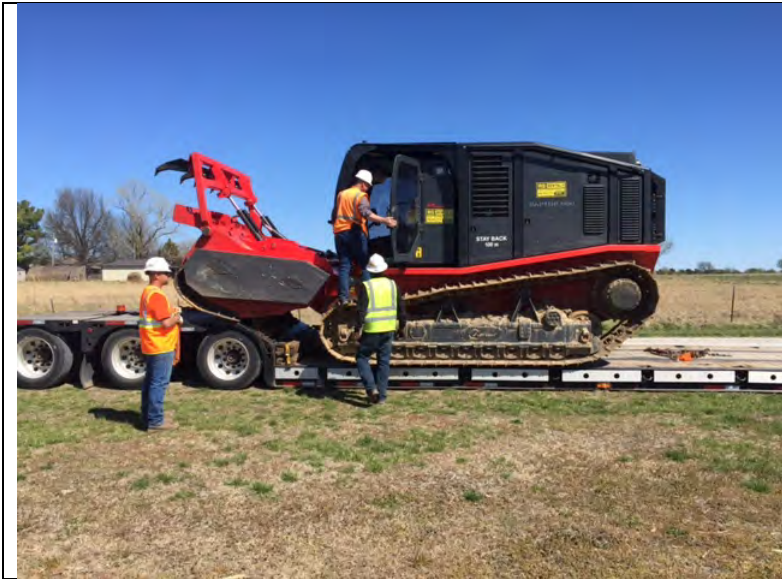
*Photograph 20*  
*TCOU4 DISTAL 4, CP091 Mobilization of Rock Crusher (Raptor 800), 2016-03-28*

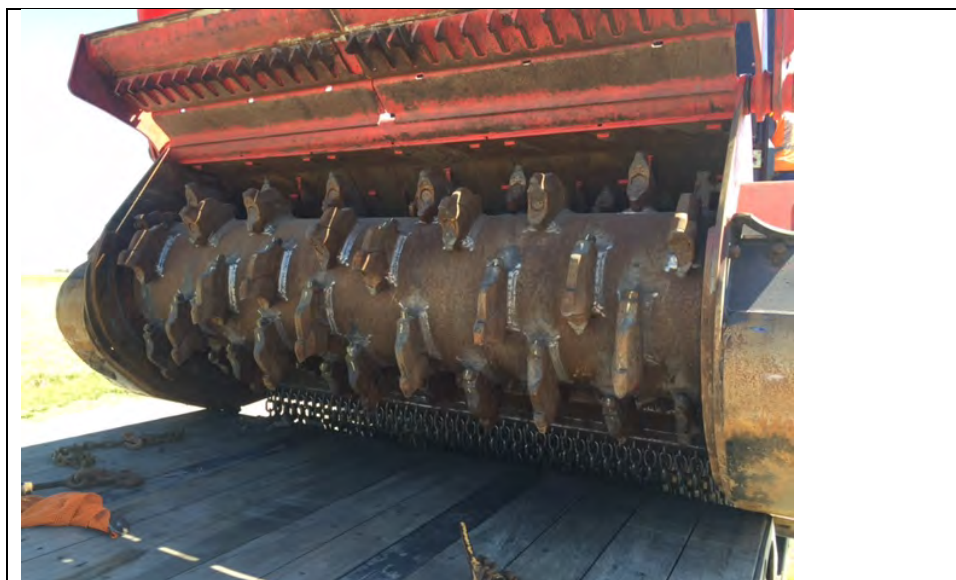
*Photograph 21*  
*TCOU4 DISTAL 4, CP091 Closeup of Rock Crusher Teeth, 2016-03-28*

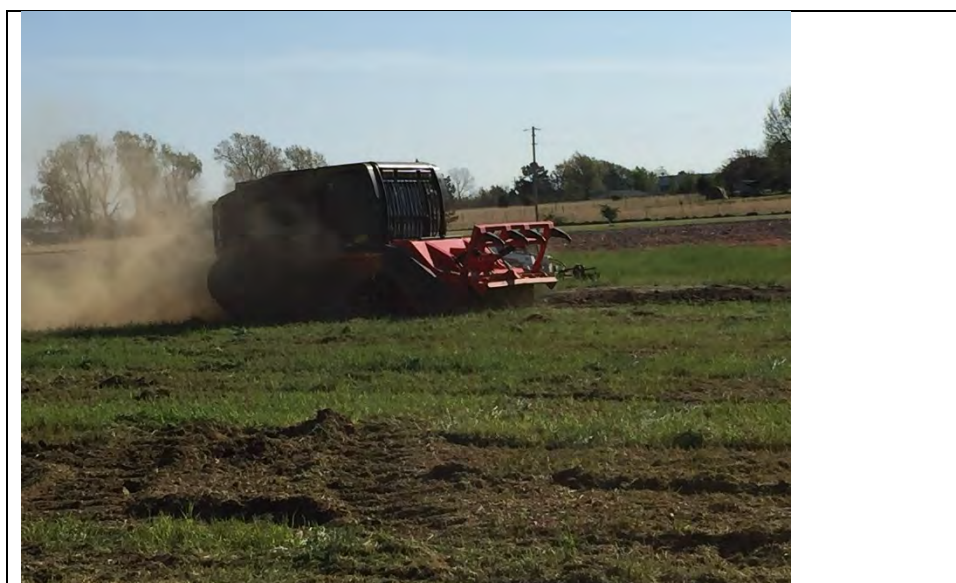
*Photograph 22*  
*TCOU4 DISTAL 4, CP091 Raptor 800 Rockcrushing, 2016-03-29*

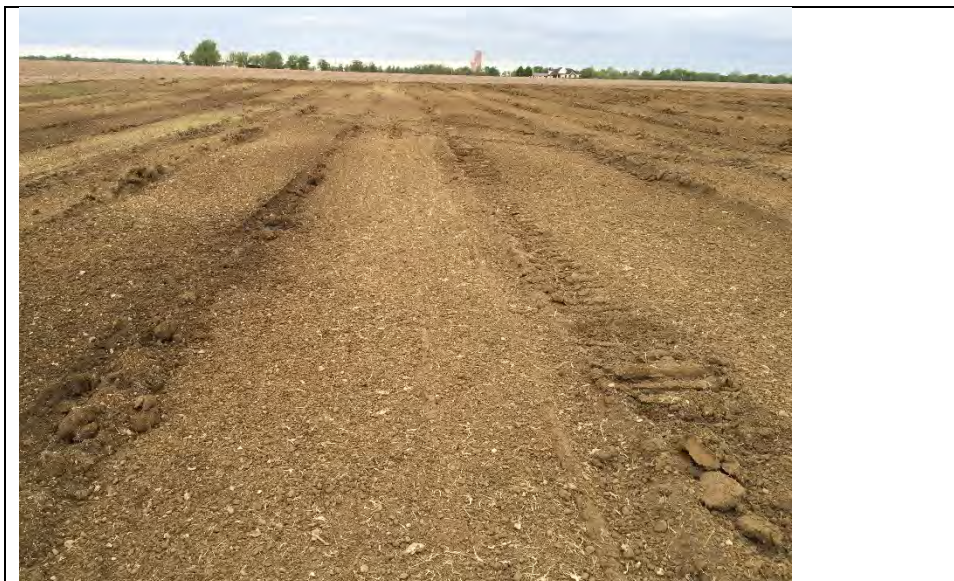
*Photograph 23*  
*TCOU4 DISTAL 4, CP091 Cap Surface Following Rockcrushing, 2016-04-17*

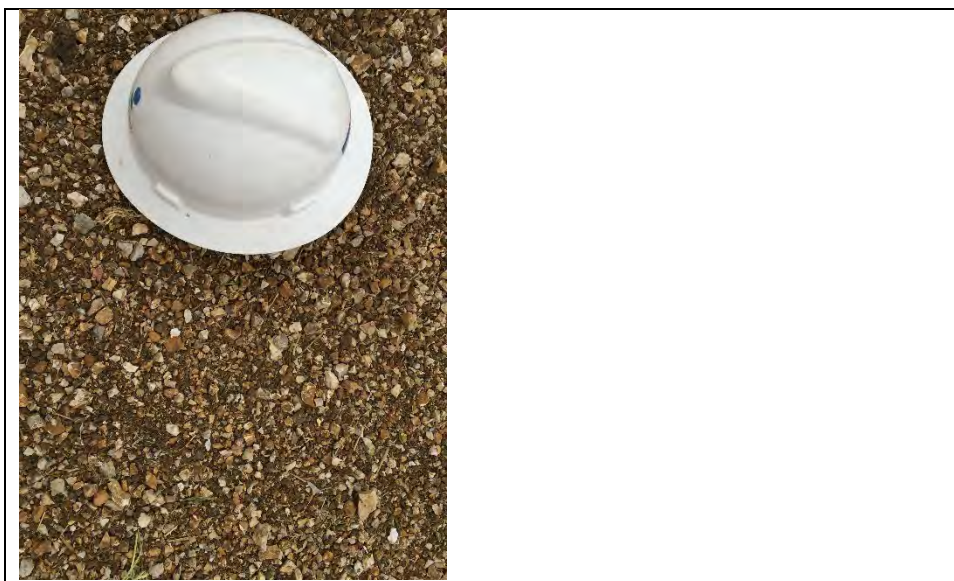
*Photograph 24*  
*TCOU4 DISTAL 4, CP091 Closeup Following Rockcrushing, 2016-03-30*

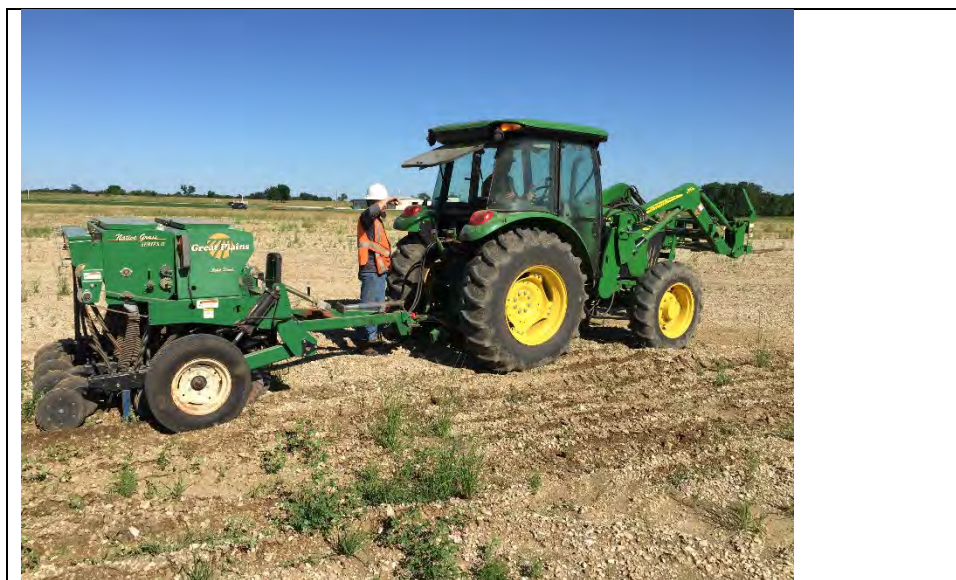
*Photograph 25*  
*TCOU4 DISTAL 4, CP091 Seeding, 2016-06-09*

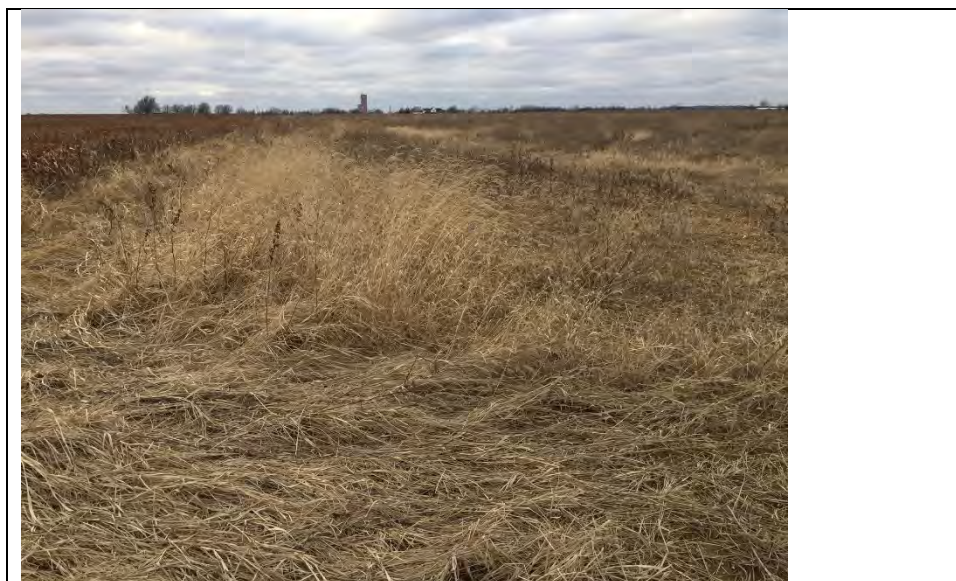
*Photograph 26*  
*TCOU4 DISTAL 4, CP091 Cap after Restoration Complete-During Final Inspection, From Southeast Corner pf CP091 Facing West, 2017-01-19*

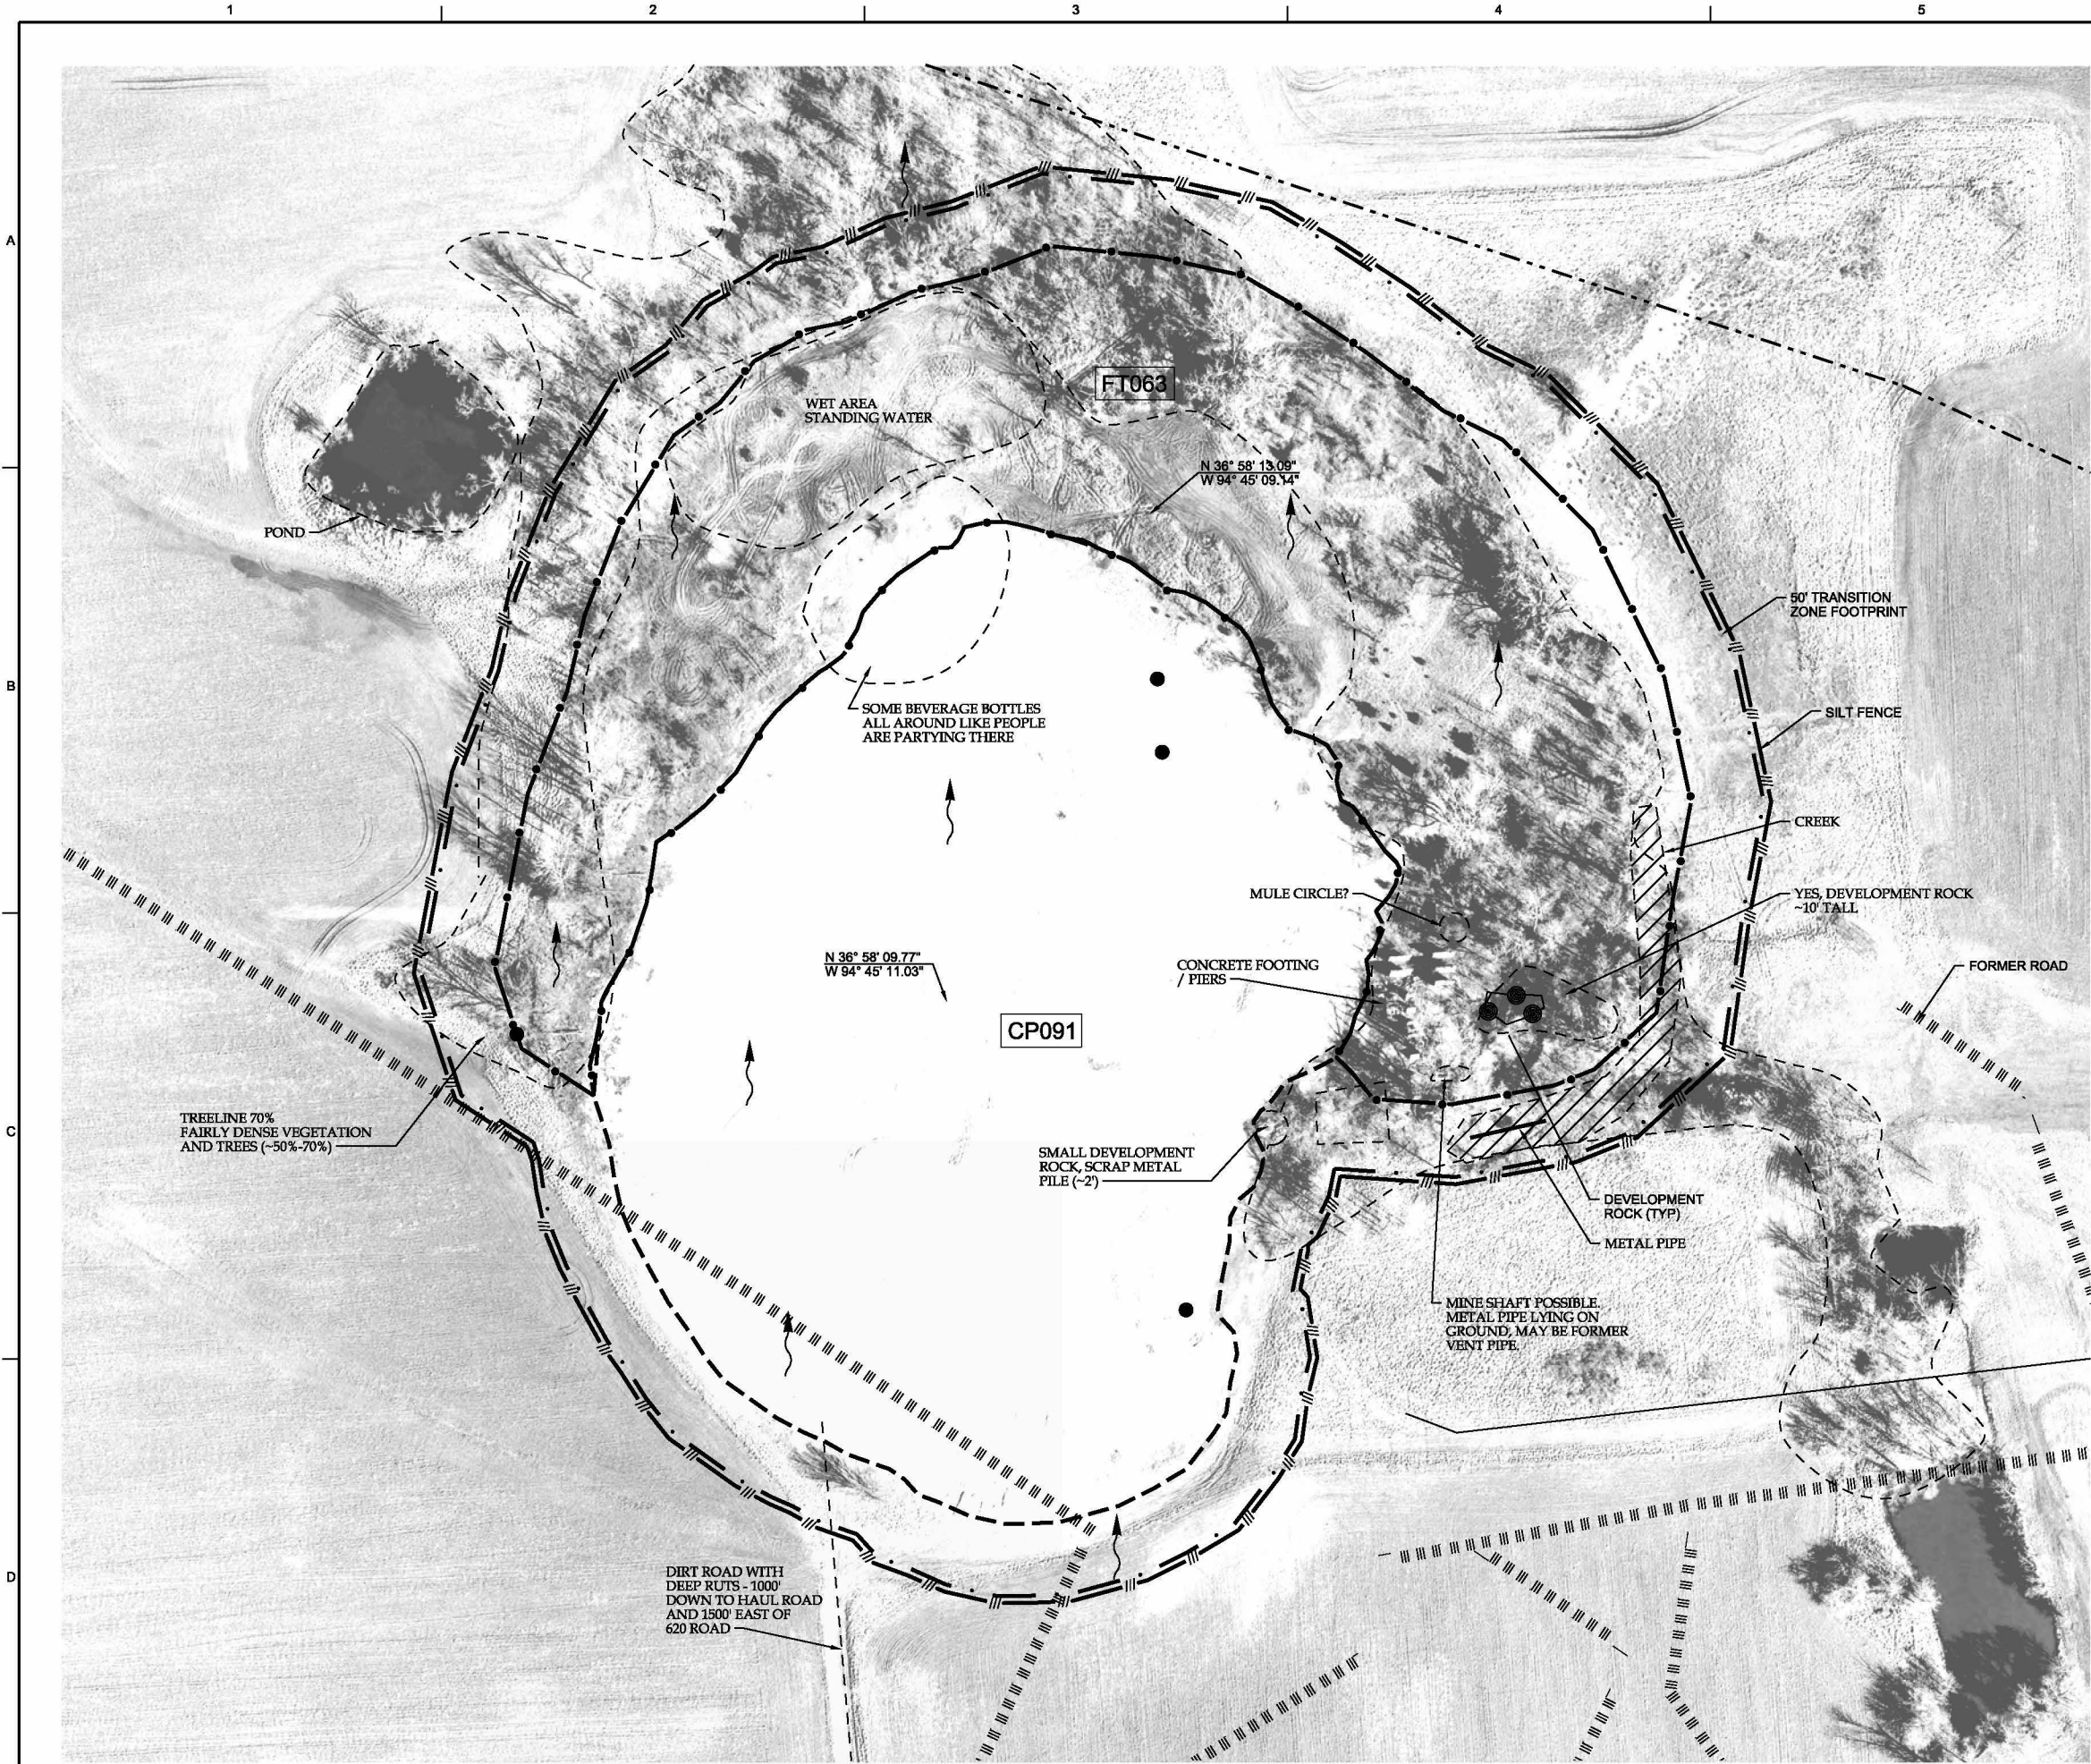
SOUTHEAST DISTAL AREA  
OVERALL GRADING PLAN  
INCLUDING FT063 & CP091

RECONNAISSANCE NOTES

THERE IS ONE DEVELOPMENT ROCK PILE SE OF THE FOOTINGS THAT IS ABOUT 10' TALL AND ONE SMALL PILE TO THE SW THAT CONTAINS CONCRETE, SCRAP METAL AND DEVELOPMENT ROCK. BEVERAGE BOTTLES ARE LITTERED AROUND THE NW CORNER OF THE PILE. THERE IS NO VEGETATION OVER THE PILE. MOSTLY GRASSY AREA OVER FINE TAILINGS AREA. THE NORTHERN HALF IS ALL SURROUNDED BY DENSE TREES (50-70%) COVERAGE. OUTSIDE THE TREELINE IS GRASS AND FARMLAND. THERE IS ONE POND NW OF THE PILE AND ONE POND SE OF PILE. LOW WET AREAS AND CREEK ON EASTERN SIDE OF PILE NEAR FOOTING/PIER AND DEVELOPMENT ROCK PILE. THERE ARE CONCRETE FOUNDATION PIERS ON EAST SIDE OF PILE. LARGE AREA OF PIERS / FOUNDATION FOOTINGS. VENT PIPES - THERE WERE SOME RUSTED METAL PIPES OBSERVED SURROUNDING THE FOOTINGS, BUT ALL ABOVE GROUND AND LYING ON THE GROUND. SHAFTS AND SUBSIDENCE FEATURES - THERE WERE TWO POSSIBLE SHAFTS. ONE IN THE SE CORNER OF THE FOOTING WEST OF THE DEVELOPMENT ROCK WITH A METAL PIPE THAT APPEARS TO DRAIN WATER FROM THE PILE INTO THE CREEK. THE OTHER IS 200'-300' E OF THE PILE IN AN OPEN FIELD, FILLED WITH ROCK AND SUBMERGED IN WATER. POST A TIRE AS A MARKER. FT063 IS THE NORTHERN HALF OF AREA SURROUNDING CP091. THERE IS A GRAVEL / HAUL ROAD RUNNING E-W FROM 620 ROAD, THEN DIRT FARM ROAD WITH DEEP RUTS RUNNING N-S TO CHAT PILE. THERE IS NO PROXIMITY TO SITE STRUCTURES. THE PROPERTY BOUNDARY IS FAR AWAY AS IS THE FENCE LINE.

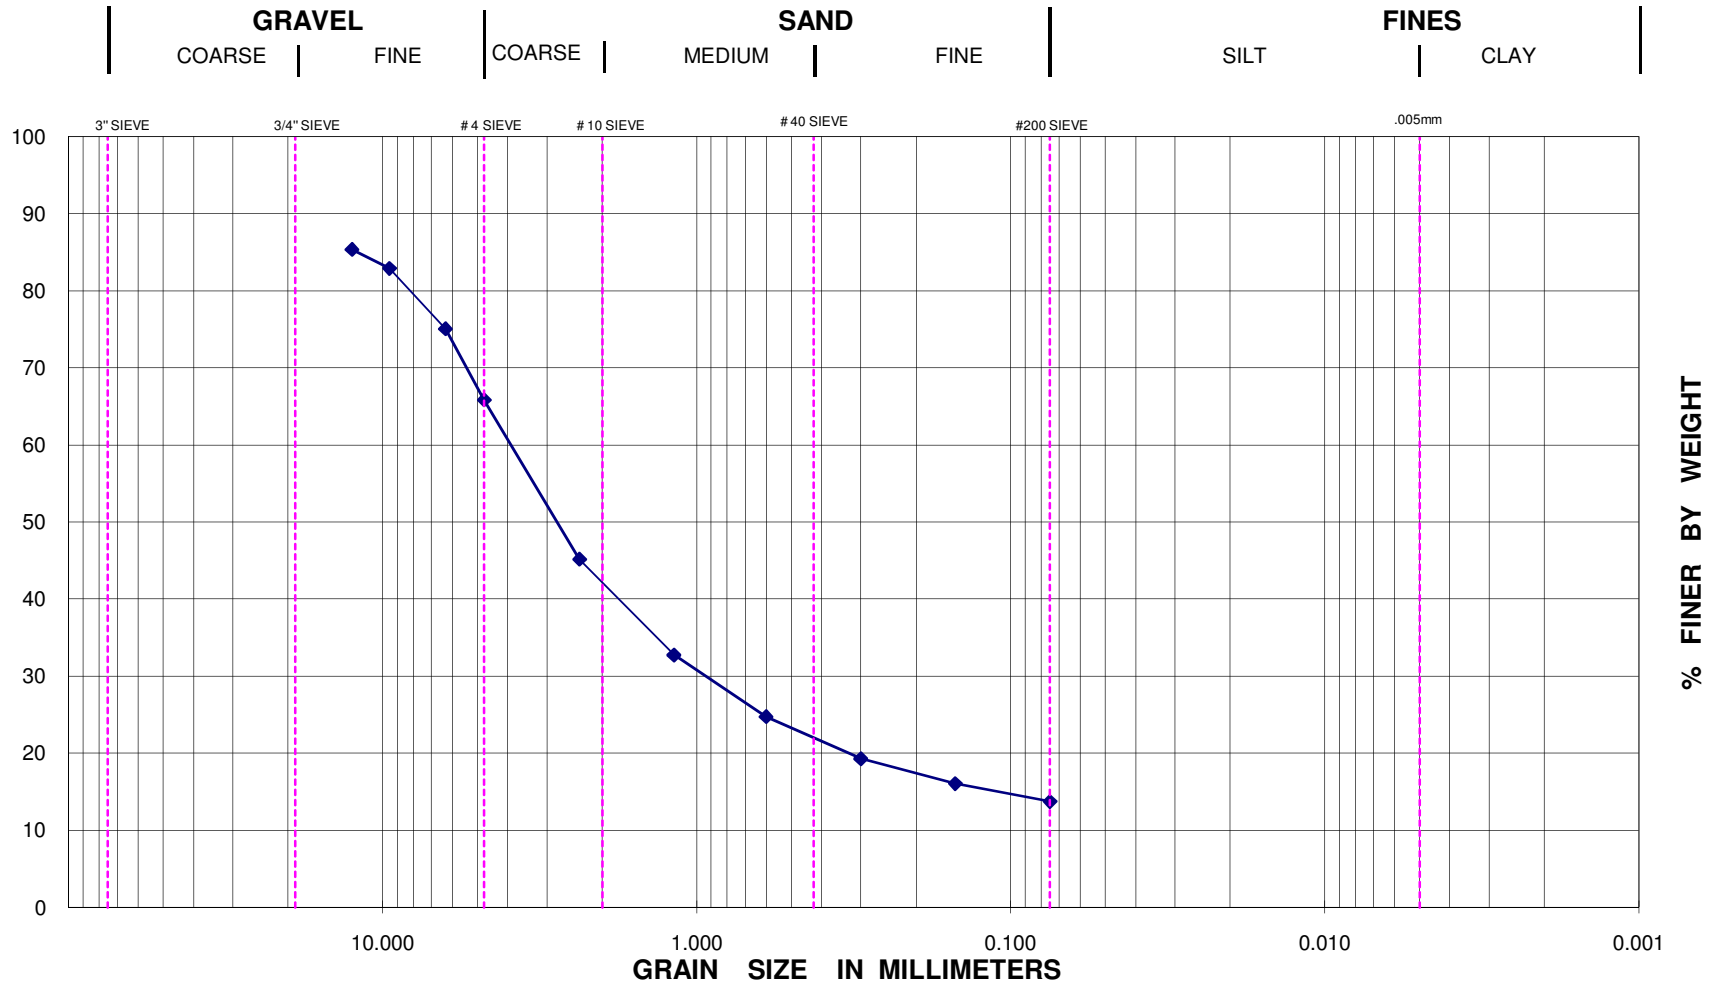
JOB NAME : Tar Creek Super Fund Cleanup - 395950		CLIENT: CH2M HILL		AE LAB NO.: JS-006	
JOB NO. : 50013-10	REPORT NO. : -	DATE : 3/19/10	REVIEWED BY : CRW		
BORING / PIT NO. : -	DEPTH / ELEV. : -	SAMPLE NO. : CB231-02	SAMPLE TYPE : Composite

SOIL DESCRIPTION : CHAT GRAVEL SAMPLE				SP. GRAVITY, G <sub>s</sub> : -	
SG Fine Agg, G bulk : 2.52	SG Fine Agg, G app.: 2.71	Fine Agg. Abs, %: 2.7%	FINES , % : 6.9%		
SG Coarse, G bulk : 2.56	SG Coarse, G app.: 2.66	Coarse Abs, %: 1.4%	COEFF. OF CURVATURE , C <sub>c</sub> : -		
CLASSIFICATION -	UNIFIED : SP-SM	AASHTO : -	COEFF. OF UNIFORMITY , C <sub>u</sub> : -

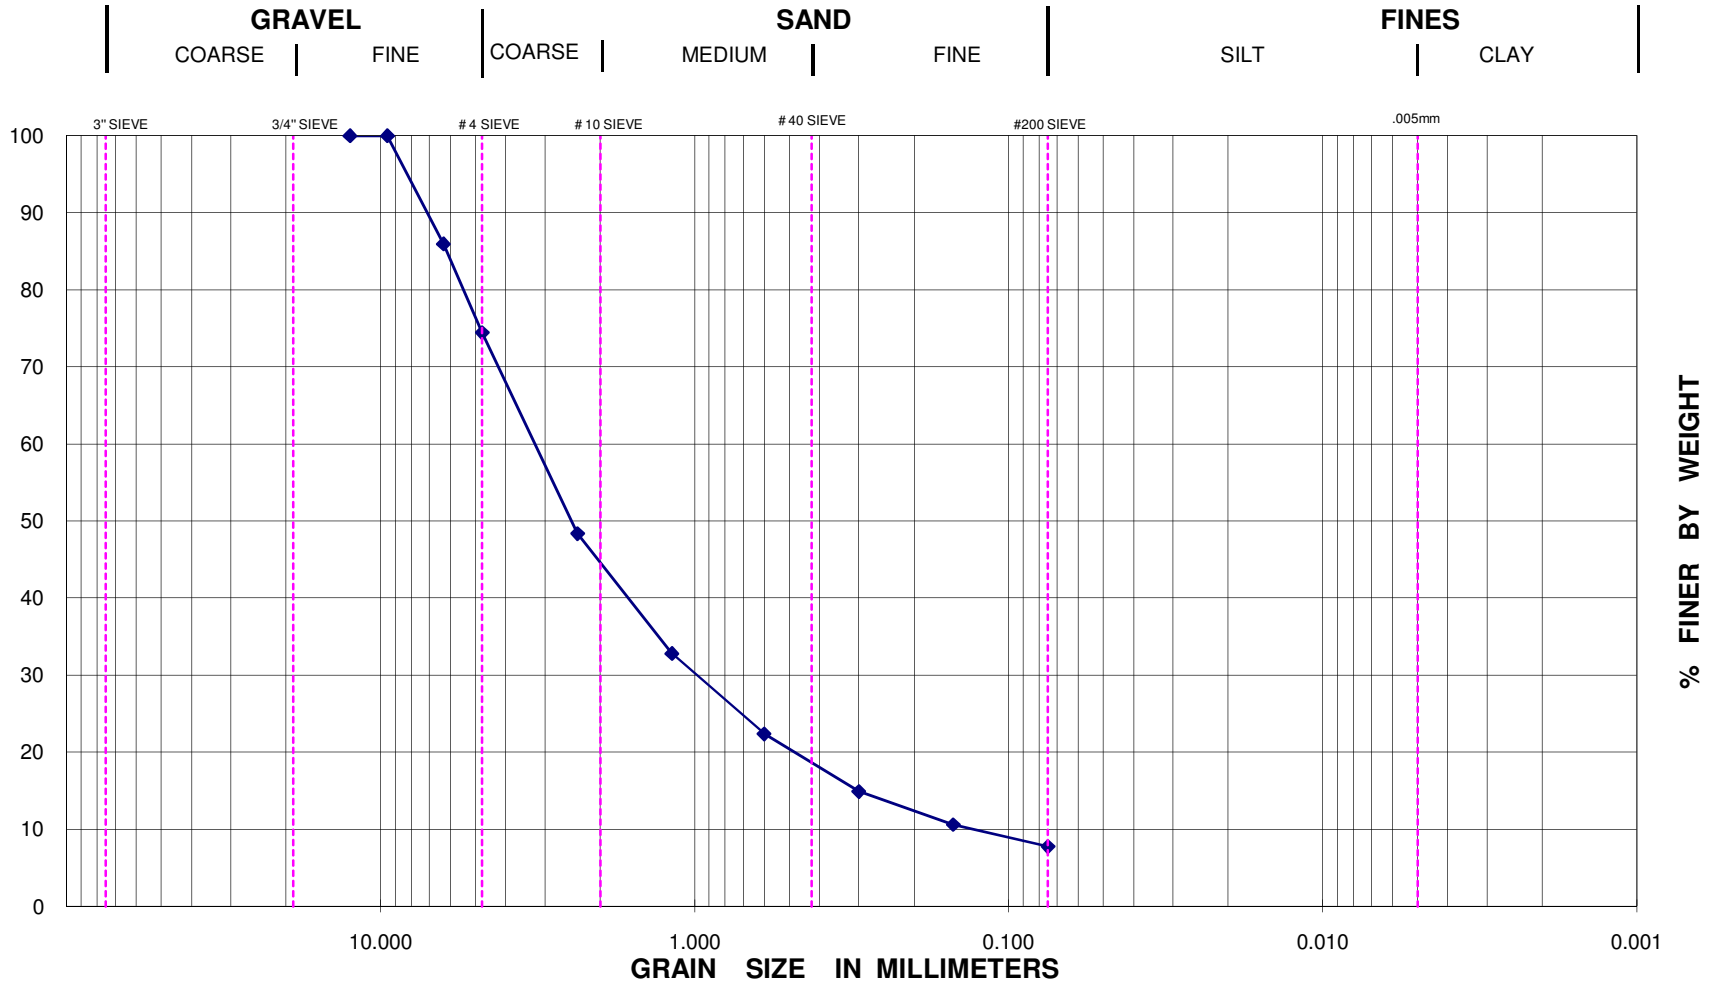
Sieve No.	Percent Retained	Cumulative Percent Retained	Percent Finer
0.5"	0.0%	0.0%	100.0%
0.375"	0.0%	0.0%	100.0%
0.25"	14.0%	14.0%	86.0%
4	11.5%	25.5%	74.5%
8	26.1%	51.6%	48.4%
16	15.6%	67.2%	32.8%
30	10.4%	77.6%	22.4%
50	7.5%	85.1%	14.9%
100	4.3%	89.4%	10.6%
200	2.8%	92.3%	7.7%
